Compendium

Transitional Learning Spaces (TLS)

Design and Construction in Emergency

2011

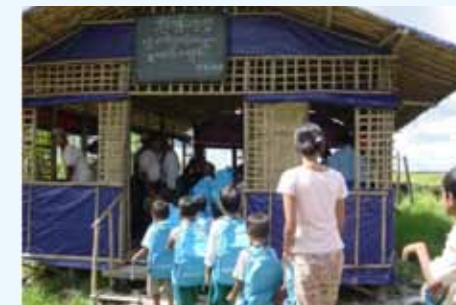
Myanmar: Bamboo TLS built with local materials rapidly after cyclone Nagris.

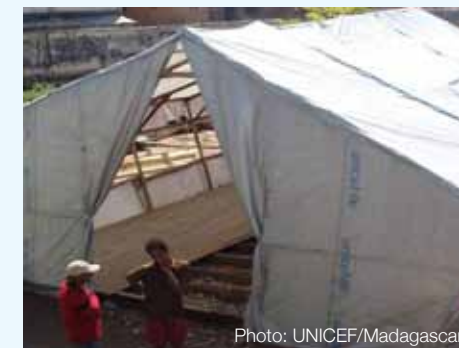
Photo: UNICEF/Madagascar
Madagascar: Upgrading of a TLS tent for with re-claimed flooring from damaged classrooms

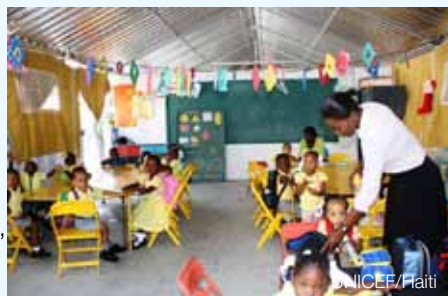
Haiti: upgraded imported steel structure TLS tent

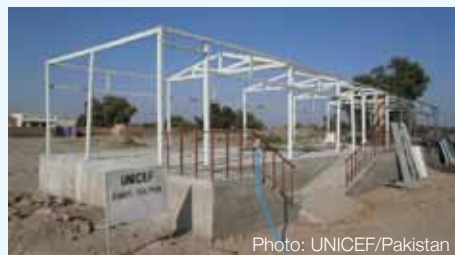
Photo: UNICEF/Pakistan
Pakistan: raised floor level to prevent flooding

In areas with risk of flooding, low lying sites or sites close to rivers or sea shores should be avoided if possible. If this is not feasible, the design of the TLS must take future flooding into consideration, as in the case study of Myanmar C 6.0 P92 and Pakistan C 13.0 P192

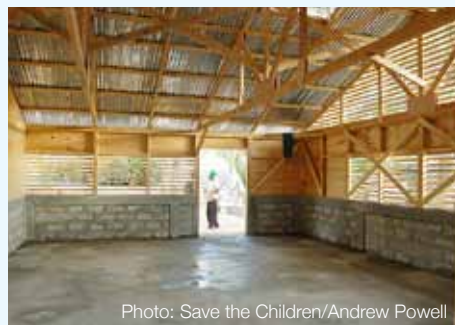
Photo: Save the Children/Andrew Powell
Haiti: Louvres protect from sun

In the case study of Haiti C12.0 P170, timber wooden louvers on the outside diffused the sunlight to give even filtered lighting condition.

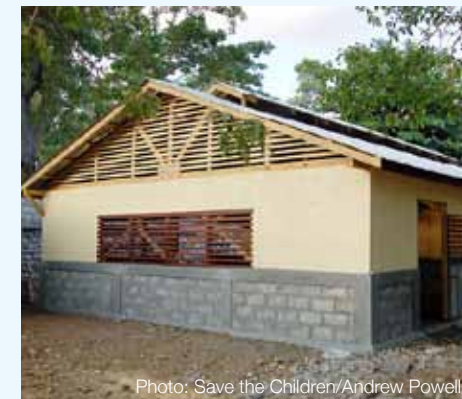
Photo: Save the Children/Andrew Powell
Haiti: roof ridge ventilation detail

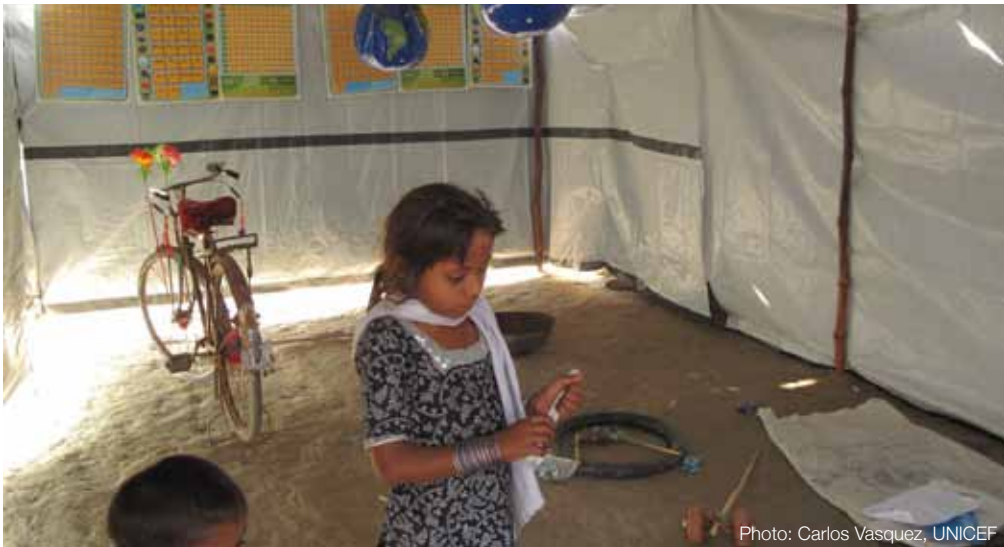
Interior of TLS with mud floor

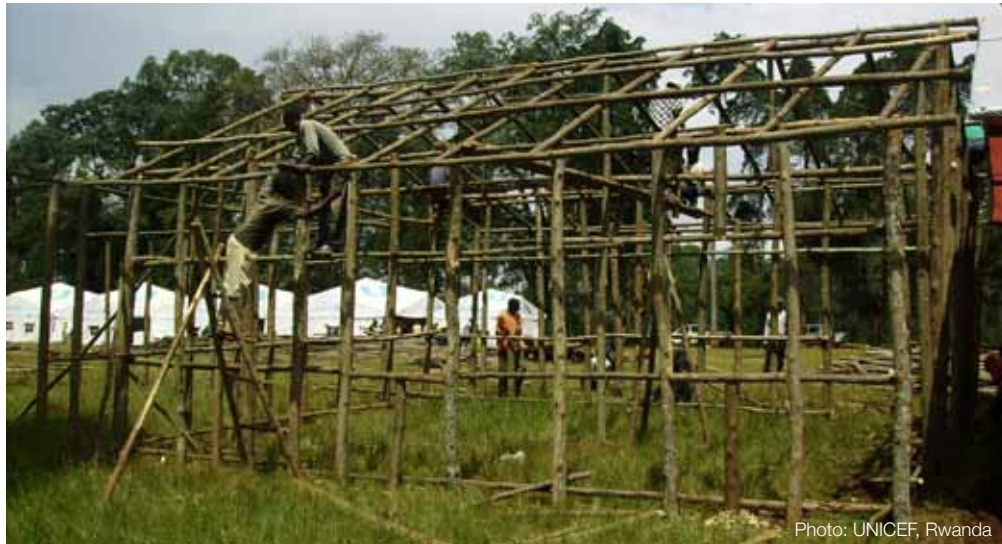
Wooden pole lattice structure, TLS under construction

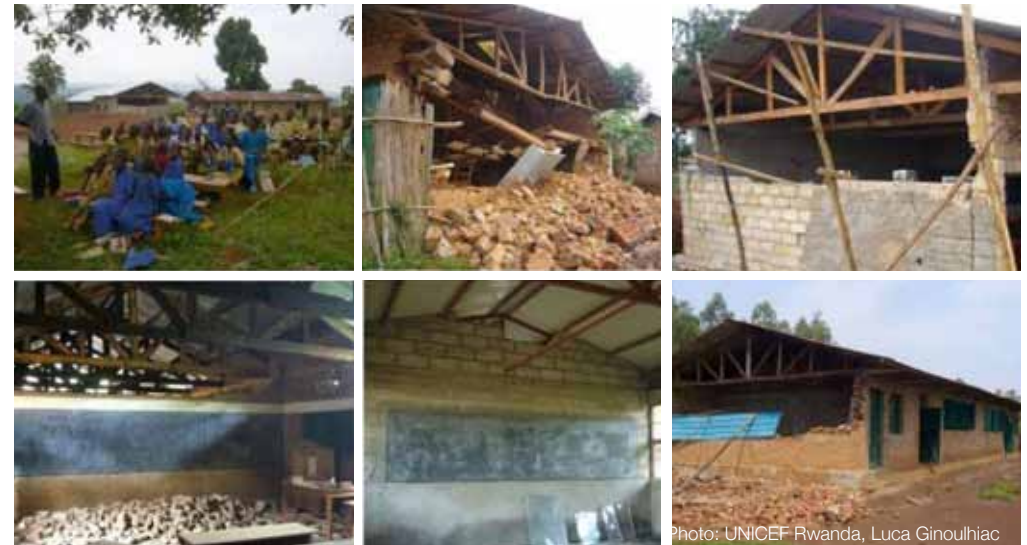
Earthquake damage on school buildings

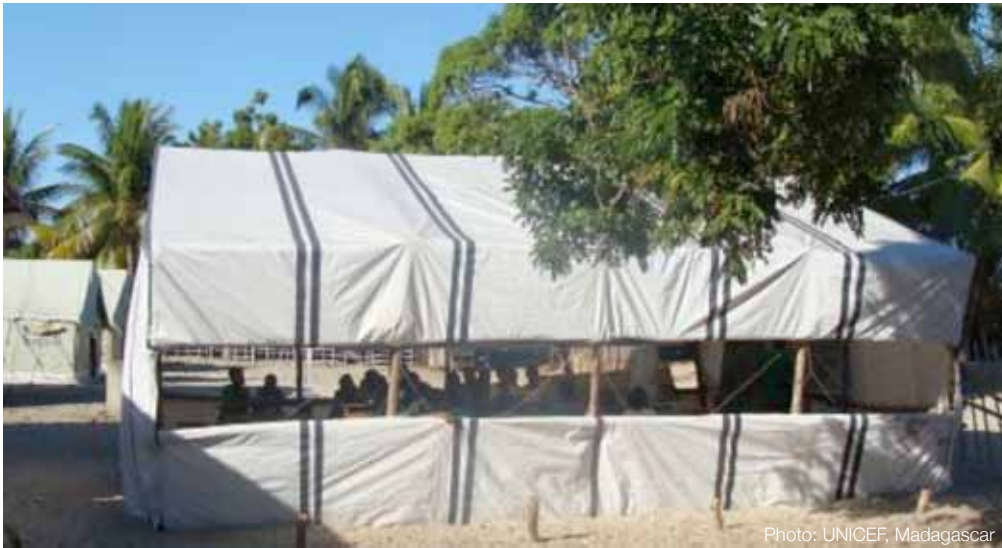
Existing vegetation providing shadow

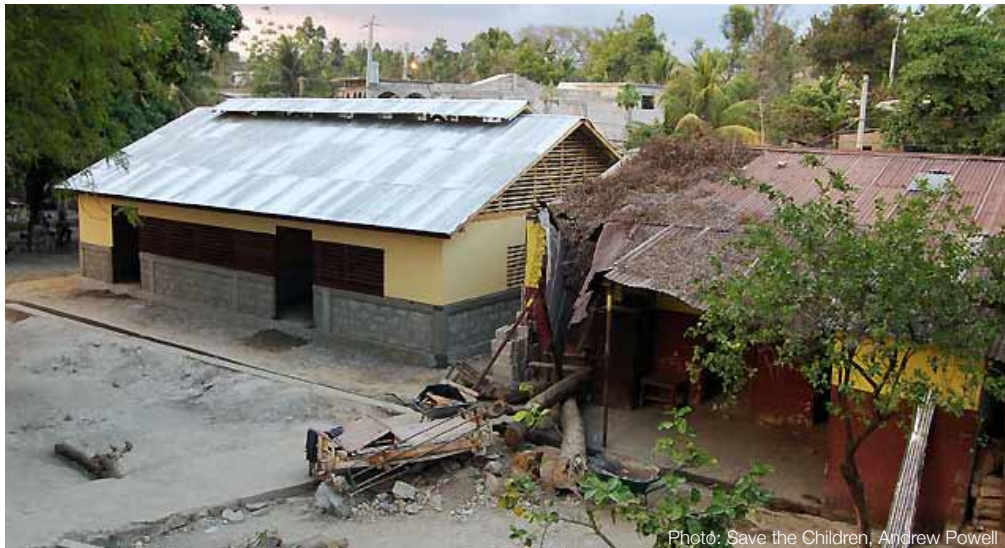
External view of masonry/timber TLS version for Ecole Siloe in Jacmel, next to damaged school building

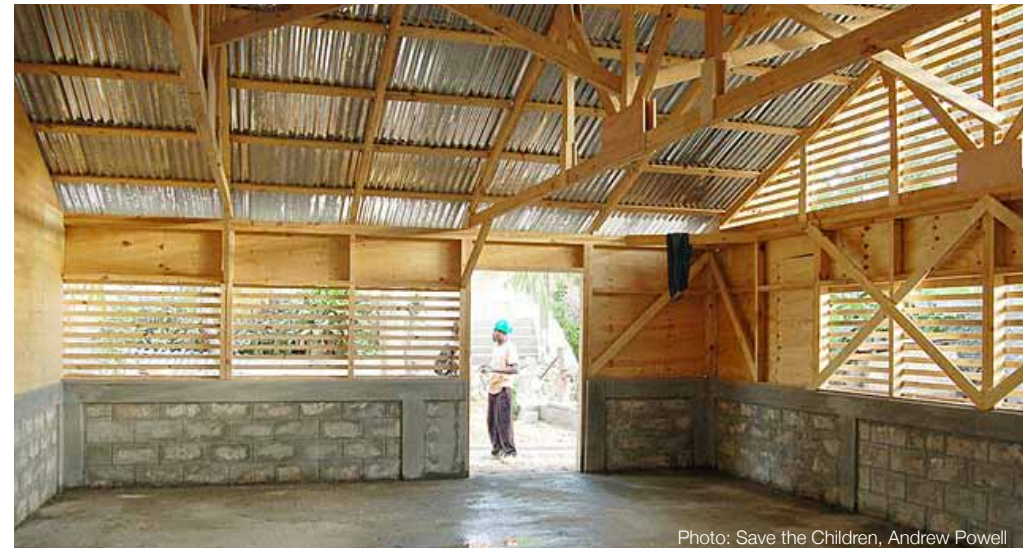
Internal view of masonry/timber TLS version for Ecole Siloe in Jacmel, showing internal natural lighting condition

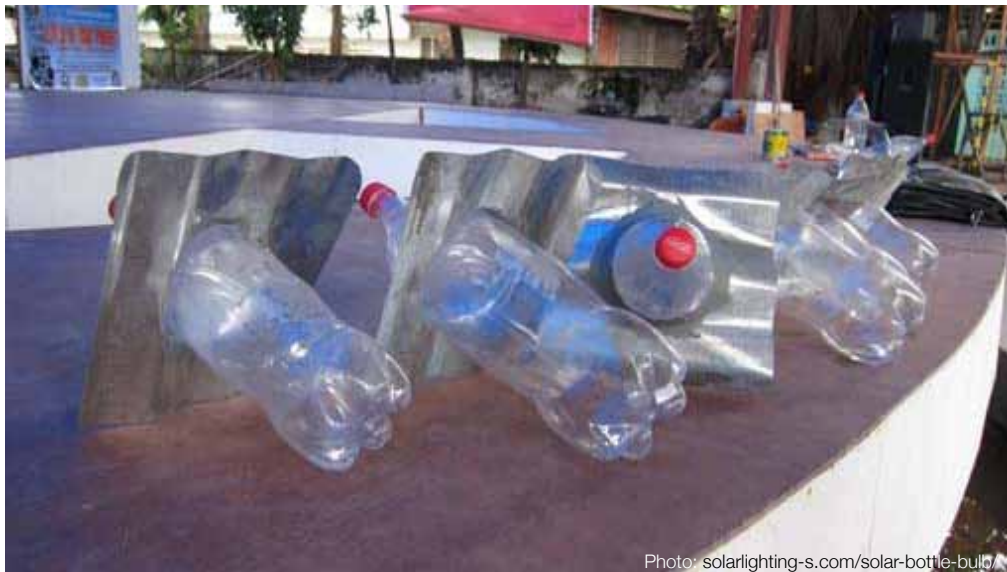
WATER BOTTLE LIGHT

- Fill plastic bottles with water and bleach then capped; bleach works to make the water clear and also to prevent fungus or microbe.
- Make holes in the metal roofs, insert the bottle **and then sealed to avoid leaks when it rains.**
- Plastic bottles refract sun light and pushed into every corner of the home rather than to high-light one area like an ordinary lamp.
- Simple technology that can be installed in less than an hour, lasting for five years, and equivalent with 60-watt light bulb.
